## The Effect of Metal Surface Treatment before Reporcelainization for Ceramic Repair After Adhesive Fracture of Ceramo-Metallic Restoration

### **Abstract**

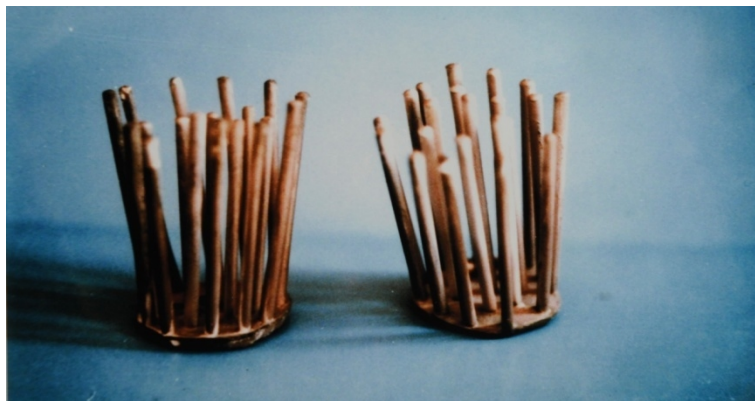
**Figure 1:** Photograph of the cast rods oriented over crucible former after casting.

All the patterns were oriented over crucible formers. Stainless steel casting rings lined with asbestos liner were applied over, and invested with phosphate bonded investment\*. Burning out was done and casting was carried out using induction casting machine\*\*. After casting, the casting rings were left to cool (Fig.1) and the rods were removed from the rings then were cut off and finally the rods were sandblasted with 250 micron aluminum oxide and porcelained with one type of ceramic. Then specimens became ready for ceramic core application (Fig.2).

Fig. (1): Photograph of the cast rods oriented over crucible former after casting.

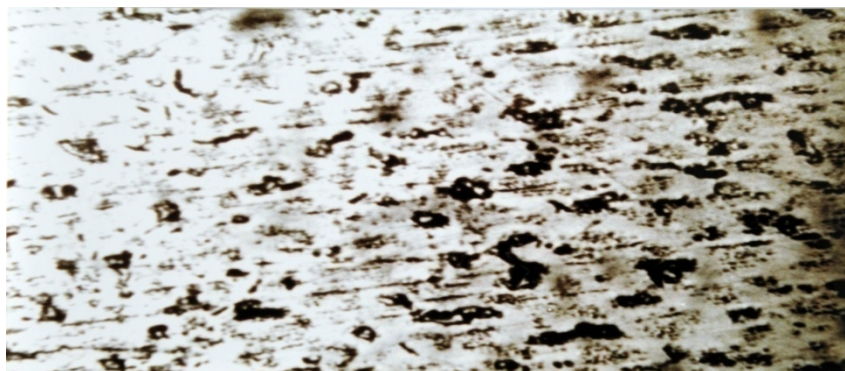
**Figure. 17:** Photomicrograph of the Co-Cr alloy.(Magnification200x4).

The structure features of the Co-Cr alloy are composed of Co-Cr solid solution forming the matrices and surrounded by tertiary and quaternary eutectics forming the cell boundaries. The metallographic picture of Co-Cr alloy is shown in Photomicrograph Fig. (7).

Fig. (17): Photomicrograph of the Co-Cr alloy.(Magnification 200x4).
