# EXPERIMENTAL BEHAVIOR OF R.C. BEAMS PARTIALLY MAGED IN FLEXURE AND STRENGTHENED WITH CFRP LAMINATES<sup>+</sup>

Qais F. Hasan<sup>\*</sup>

This study presents an experimental investigation on the monotonic flexural behavior and ultimate capacity of reinforced concrete beams partially damaged and cracked in flexure due to applying a 58% of the predicted ultimate flexural load capacity, and then repaired by external strengthening with high strength CFRP (Carbon Fiber Reinforced Polymer) laminates bonded with epoxy resin to the tension face of concrete after doing all the appropriate preparations for the concrete adhesion substrate. Five rectangular reinforced concrete beams were tested to obtain the effect of amount of CFRP laminate on beams cracking behavior, concrete strains, ductility ratios, ultimate loads and failure modes. The results obtained from the adopted repairing and strengthening technique showed a significant effect of external high strength CFRP laminates on improving behavior and capacity of reinforced concrete beams. An increase by 15%- 33% in ultimate load capacities, for the CFRP strengthened beams, was observed over the control beam with conventional reinforc

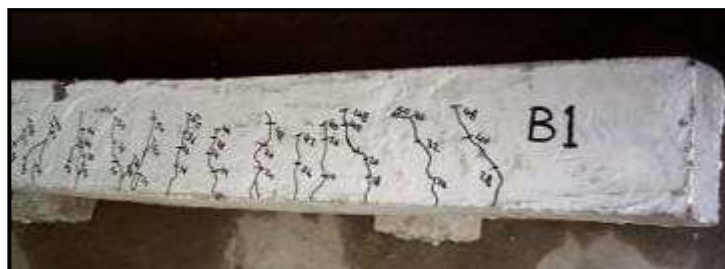
Figure (4.1) Crack pattern for control conventional beam B-1

Reloading the control beam (B-1) accompanied with rapid re-opening and widening of cracks, as shown in Fig. (4.1). While reloading the CFRP repaired beams (Fig. (4.2) to Fig. (4.5)) showed stiffer response for cracks initiation and propagation, and small percent of cracks are re-opened while most of these cracks are completely repaired and do not re-opened. This means that the epoxy resin used is enhanced the behavior of the damaged beams in crack repairing and crack formation. This enhanced behavior was proportional to CFRP amount and epoxy used in repairing the damaged R.C. beams.

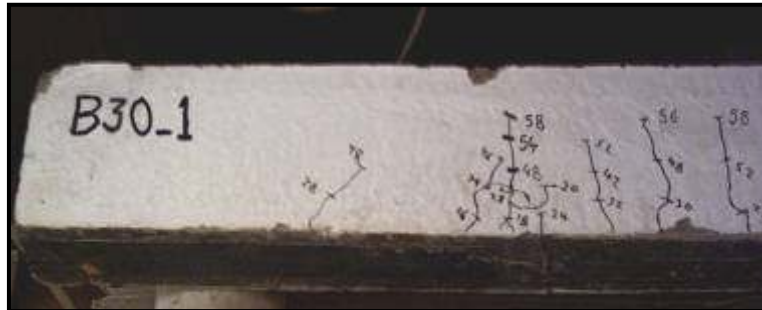
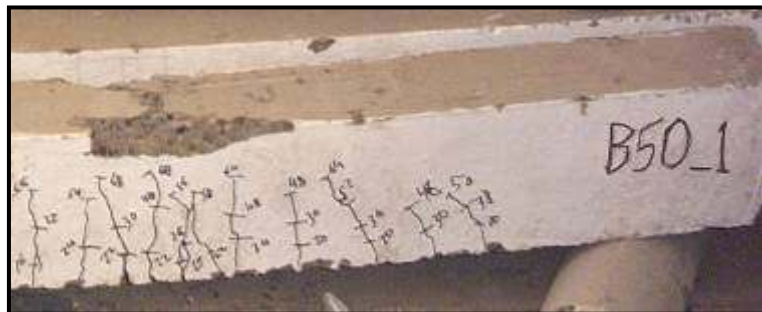
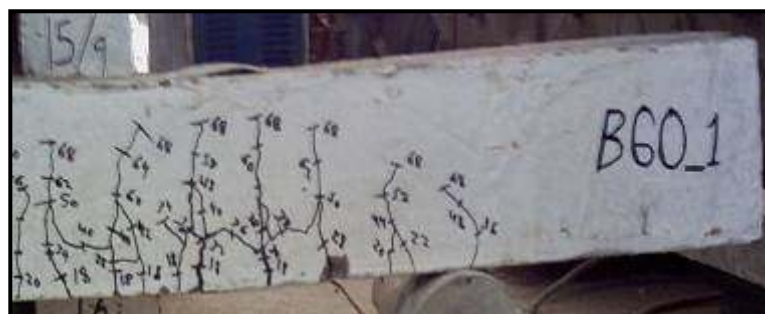
Figure (4.2) Crack pattern for strengthened beam B30-1

Figure (4.3) Crack pattern for strengthened beam B40-1

Figure (4.4) Crack pattern for strengthened beam B50-1

Figure (4.5) Crack pattern for strengthened beam B60-1
