## **Rock slope Stability Assessment for Rock Cliffs at Tar Al-Sayyed Area (Karbala Governorate\ Middle of Iraq)**

S. N. Al-Saadi -Baghdad University, College of Science, Department of Earth Sciences

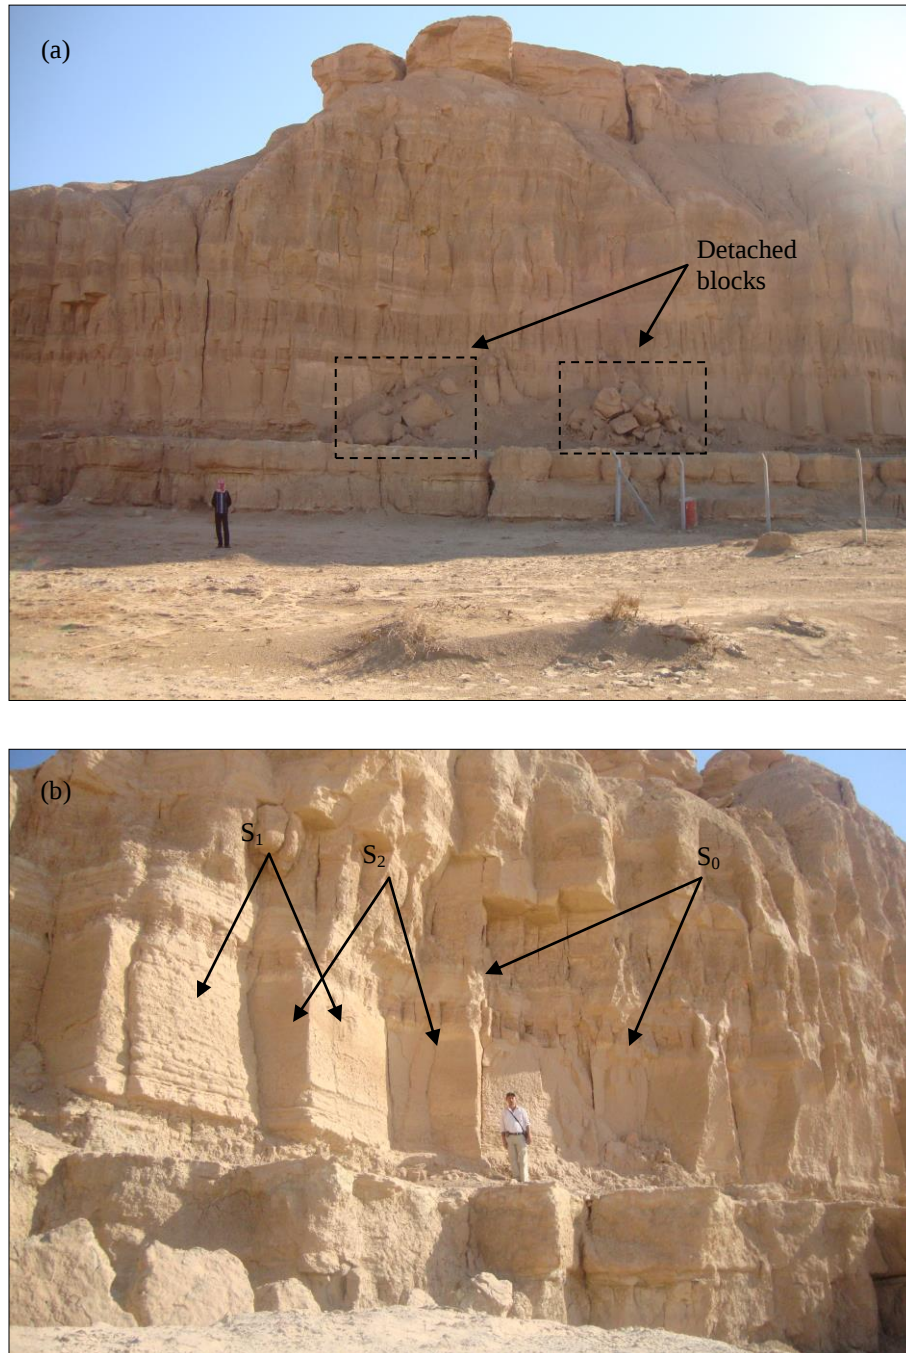
The sandstone layers are cut by two sets of subvertical joints in (S1&S2), (fig. 2). The spacing of joints in (S1) ranges between (0.5-2.1m), their persistence reaches (5m) on the bedding plane and on the slope and they are open with aperture that ranges between (0.01-0.03m). The spacing of joints in (S2) ranges between (0.5-2.2m), their persistence reaches (5m) on the bedding plane and on the slope and they are open with apertures that ranges between (0.01-0.03m), (plate 1-b).

Rock fall is regarded as the principal failure mode in this station, because of the high steepness of the slope. Some fallen blocks exist at the toe of the slope. Some sandstone slabs subparallel to the slope face may topple where the claystone layers below them are eroded. This toppling will be due to undercutting. Joints in (S1) will act as back release surfaces (BRS) while those in (S2) will act as lateral release surfaces (LRS).

Plate (1) The slope at station No.(1). (a) Front view showing detached blocks, photo direction is E. (b) Side view showing discontinuities, photo direction is SE.

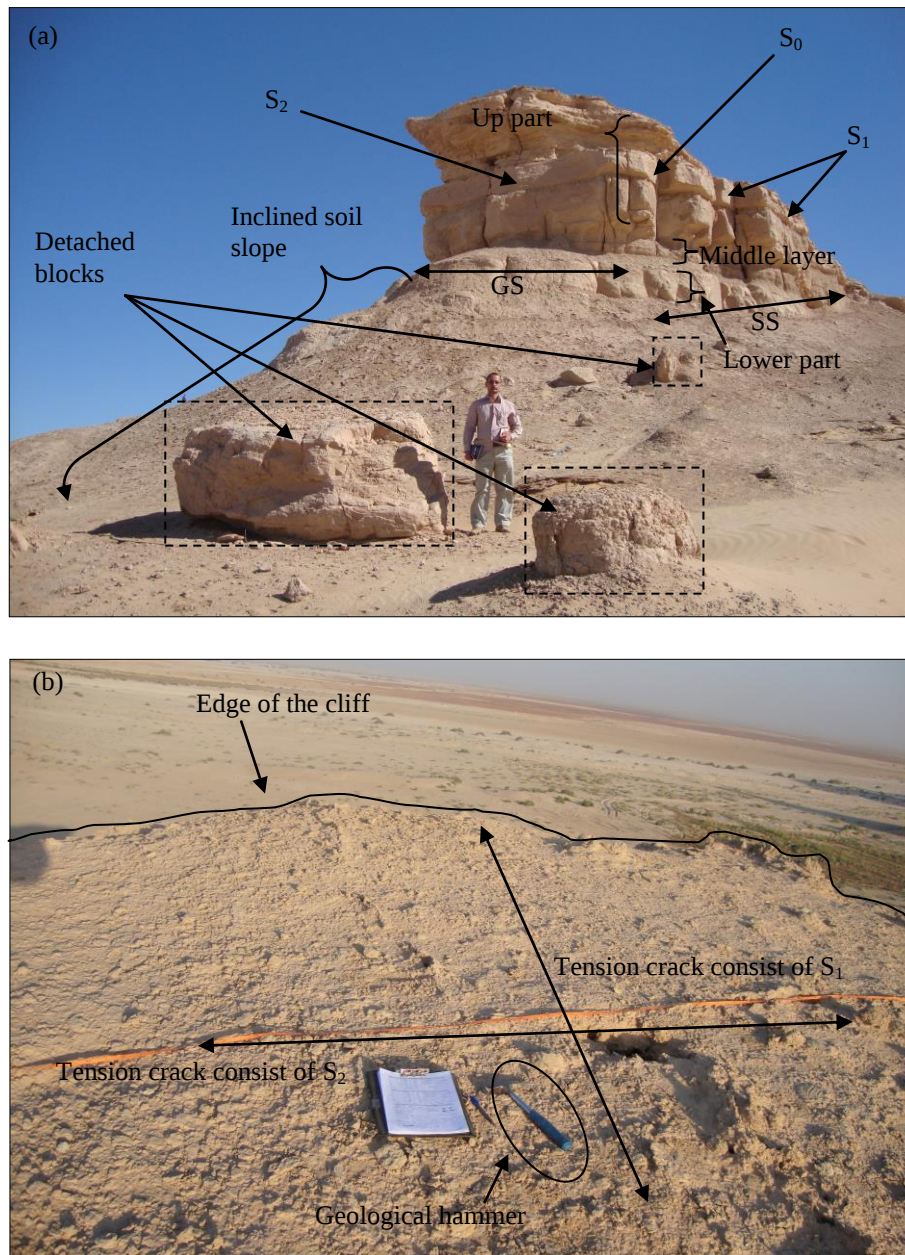
The sandstone layers are cut by two sets of subvertical joints in (S1&S2), (fig. 3). The spacing of joints in (S1) ranges between (0.4-2m), their persistence reaches (7m) on the bedding plane and the slope, they are almost open up to (0.25m). The spacing of joints in (S2) ranges between (0.4-2m), their persistence reaches (7m) on the bedding planes and the slope and most of them are open up to (0.2m), (plate 2-a).

There is a composite tension crack that consists of joints in (S1) &(S2) in the upper slope. It is (9m) long, (0.2m) wide and (5m) deep, (plate 2-b). Toppling in this station has occurred by tension crack and toppling & slumping mechanisms accompanied by differential erosion in the highly weathered claystone in the middle part of the slope. In the general slope (slope1), joints in (S1) act as lateral release surfaces (LRS), while joints in (S2) act as back release surfaces (BRS), in the side slope (slope2), joints in (S1) act as back release surfaces (BRS) while joints in (S2) act as lateral release surfaces (LRS) also during toppling. There is another failure type in the same rock mass. It is rock fall, from the upper part of the slopes, by differential erosion, which caused the sandstone layers free to fall. The inclined soil slope helps rolling of detached rock blocks.

Plate (2) The slope at station No.(2). (a) General view showing general slope, side slope, detached blocks and discontinuities, photo direction is E. (b) Top view showing the trace of composite tension crack (tension crack mostly covered with sediment), photo direction is NW.

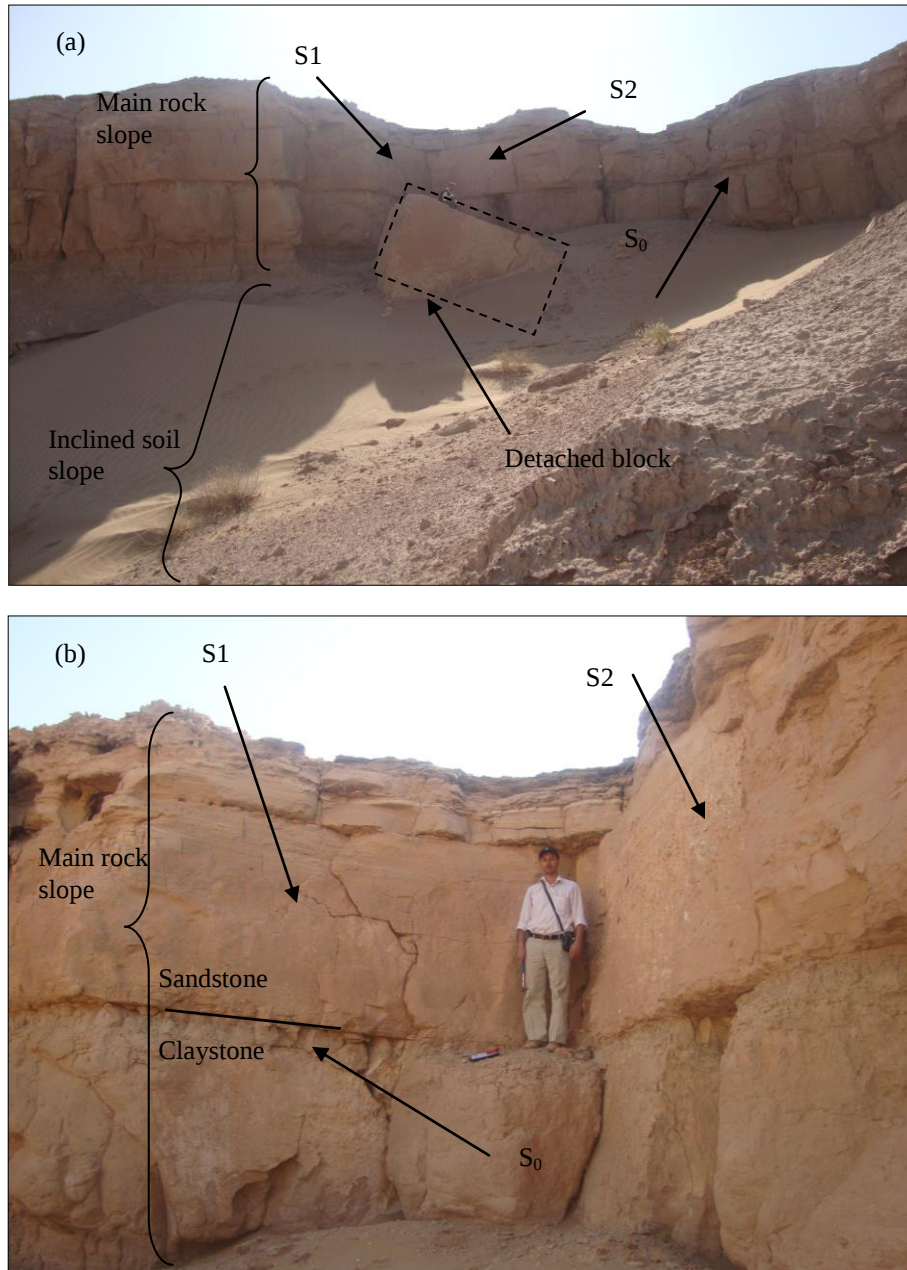
The rock mass layers are cut by two sets of subvertical joints in (S1&S2), (fig. 4). The spacing of joints in (S1) range between (0.9-1.8m), their persistence reaches (4m) on the bedding plane and they are almost open up to (0.1m). The spacing of joints in (S2) ranges between (0.9-1.6m), their persistence reaches (4m) on the bedding plane and they are almost open up to (0.1m), (plate 3-b).

Rock block failure has occurred by rock fall or secondary toppling including, multidirectional toppling mode<sup>(15)</sup>, that involves tension crack toppling and toppling & slumping mechanisms. In the first toppling process (T1) joints in (S1) set acted as back release surfaces (BRS) of the toppled block while (S2) joint set acted as lateral release surfaces (LRS), (fig. 4). Then, the toppled block underwent further rotation to the front of the slope. The inclined soil slope (below the main rock slope), and its surface roughness led again to divert the weight vector of the toppled block outside its new secondary base (the resting surface after the first toppling process), leading to a second toppling process (T2) which changed the attitude of the bedding planes within the toppled slab to vertical position. The (S2) joint set acted as back release surfaces (BRS), while the (S1) joint set acted as lateral release surfaces (LRS) during the second toppling movement.

Plate (3) The slope at station No. (3). (a) Front view showing the main slope, rock block detached by multidirectional toppling, and discontinuities. Photo direction is SE (b) Side view showing local slope and discontinuities, photo direction is NE.

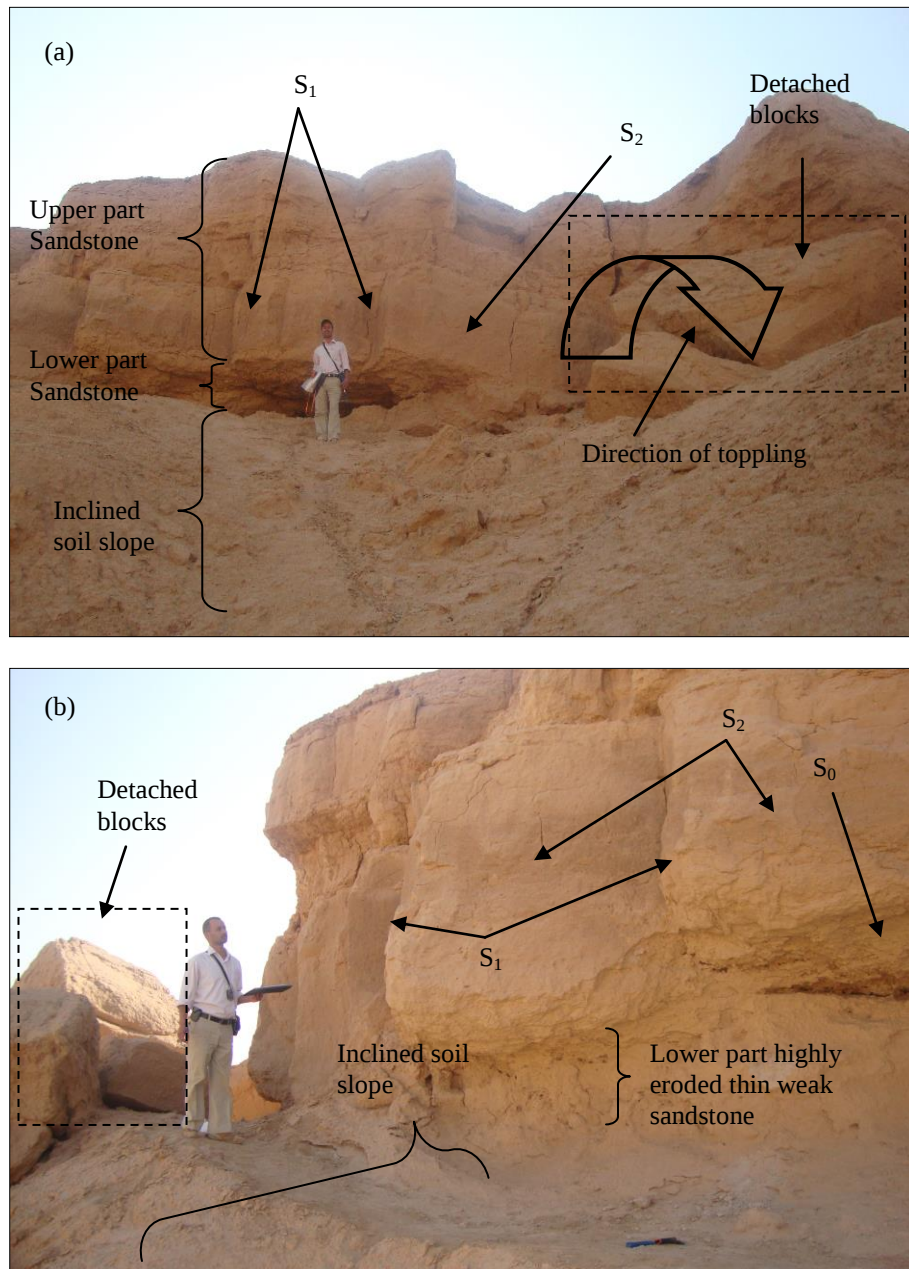
The upper sandstone layers are cut by two sets of subvertical joints in (S1&S2), (fig. 5). The spacing of joints in (S1) range between (0.9-1.1m), their persistence reaches (2m) on the bedding plane and on the slope and they are open with apertures about (0.01m). The spacing of joints in (S2) range between (1-2.3m), their persistence reaches (2m) on the bedding plane and on the slope and they are open with apertures that range between (0.01-0.07m), (plate 4-a & b).

The sandstone layer in the lower part of the slope is highly weathered and eroded, leaving some parts of the slope overhanging, this has resulted in secondary toppling of sandstone blocks by differential settlement toppling mode. Joints in (S1) acted as lateral release surfaces (LRS), while those in (S2) acted as back release surfaces (BRS) during toppling. Rock fall has occurred in this steep overhanging slope and is likely to occur in the future. The inclined soil slope helps rolling of detached rock blocks.

Plate (4) The slope at station No.(4). (a) Front view showing discontinuities and detached blocks, photo direction is SE. (b) Side view showing, discontinuities, an other detached blocks, photo direction is E.

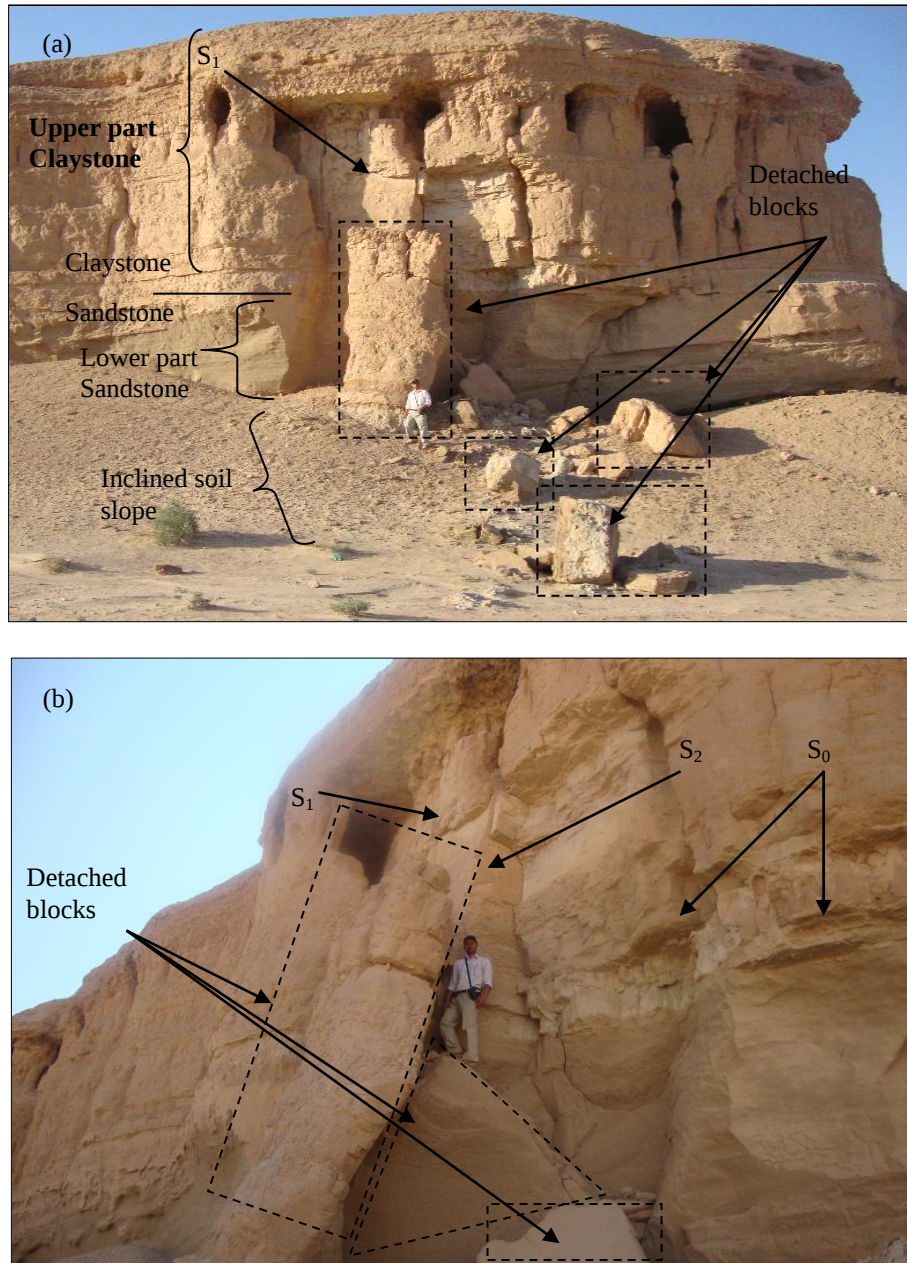
The claystone layers are cut by two sets of subvertical joints in (S1&S2), (fig. 6). The spacing of joints in (S1) ranges between (0.9-1.2m), their persistence reaches (6m) on the bedding plane they are almost open up to (0.05m). The spacing of joints in (S2) ranges between (0.5-2.3m), their persistence reaches (6m) on the bedding plane and they are almost open up to (0.1m), (plate 5-b).

The failure in this station has occurred by secondary toppling type, toppling and slumping mode. Joints in (S1) acted as back release surfaces (BRS), while those in (S2) acted as lateral release surfaces (LRS) during toppling. Rock fall has already occurred and it is likely to occur in the future. The inclined soil slope helps rolling of detached rock block.

Plate (5) The slope at station No.(5). (a) Front view showing detached blocks, claystone & sandstone contact, and some caves in upper part of the slope, photo direction is SW. (b) Side view showing discontinuities and detached blocks, photo direction is SE.

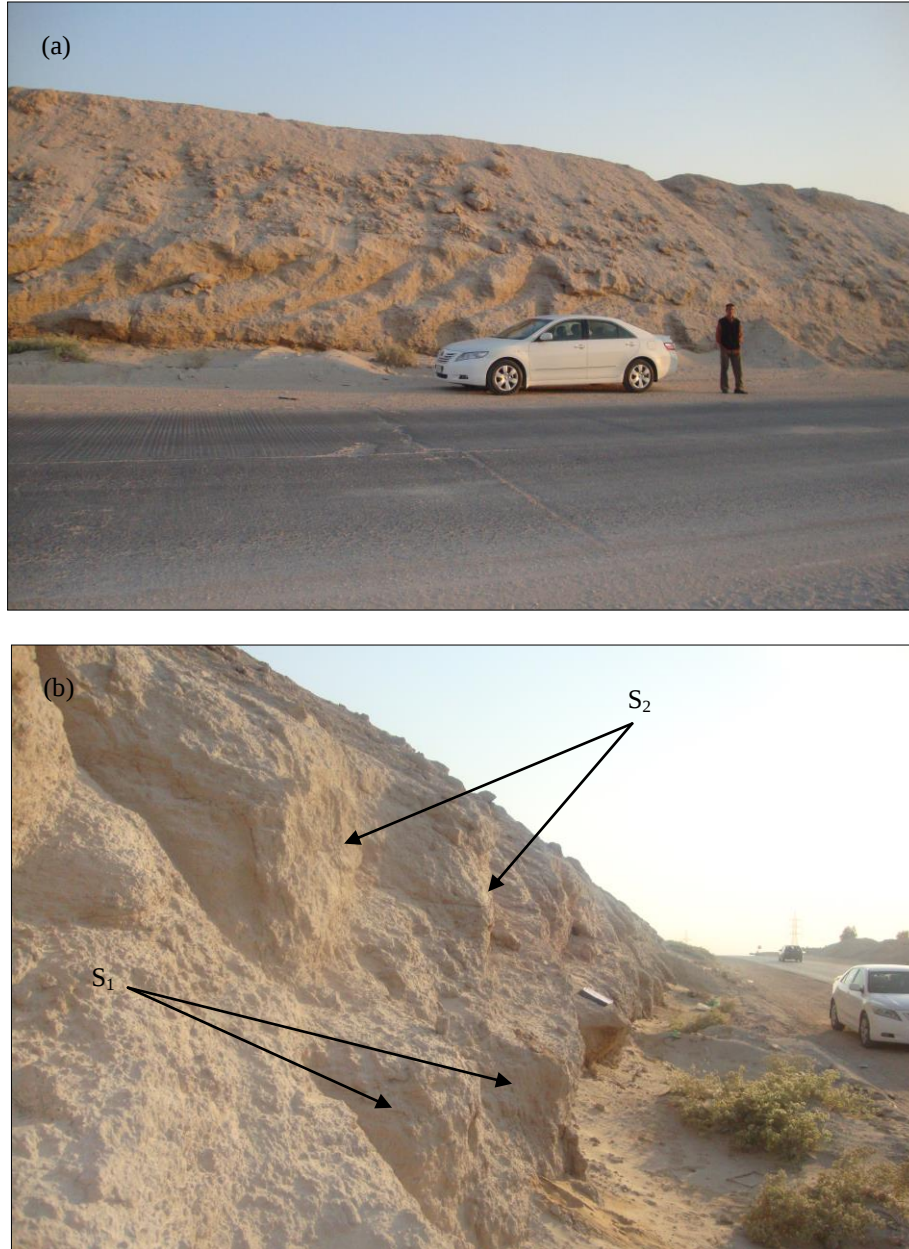
With differential erosion at the toe of the slope, in some parts, the slope is overhanging, helping in rock fall, whereas the general slope angle ( $64^\circ$ ) is helping in rock roll of the detached blocks. The other parts have failed by granular disintegration because of the weak rock (friable sandstone) forming the slope.

Plate (6) The slope at station No.( 6). (a) Front view showing the slope, photo direction is NE. (b) Side view showing the irregular-overhanging slope, and discontinuities, photo direction is E.

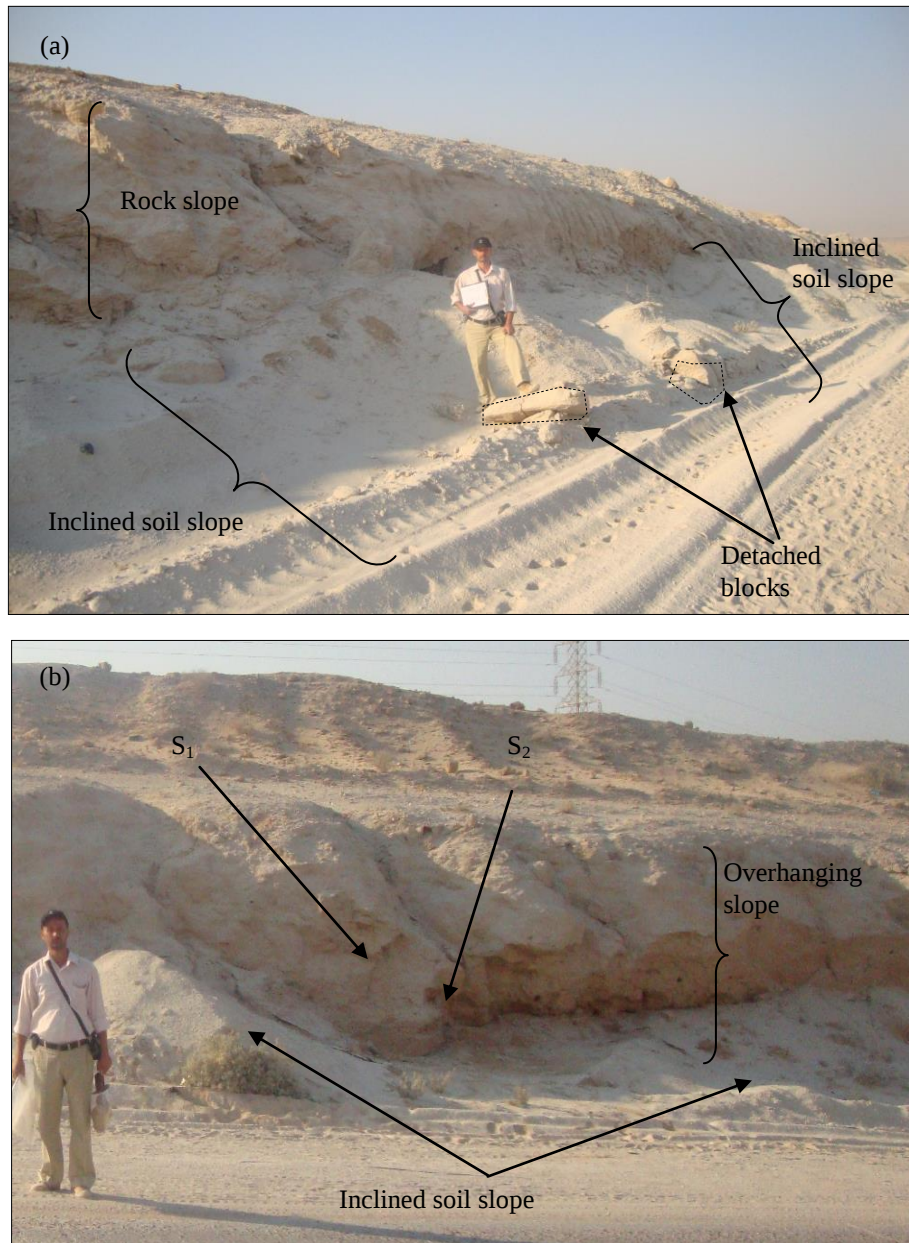
The rock mass for this slope consists of light orange pink, medium grained, massive, widely-very widely jointed, slightly-moderately weathered, SANDSTONE. The sandstone is cut by two sets of subvertical joints in (S1&S2), (fig. 8). The spacing of joints in (S1) ranges between (1.7-2.3m), their persistence reaches (1m) on the slope and they are almost open up to (0.01m). The spacing of joints in (S2) ranges between (0.8-1.1m), their persistence reaches (1.2m) on the slope and they are almost open up to (0.02m), (plate 7-b).

With differential erosion at the toe of the slope, in some parts, the slope is overhanging, helping in rock fall failure, whereas the other parts have failed by granular disintegration because of the weak rock (friable sandstone) forming the slope. The inclined soil slope helps rolling of detached rock blocks.

Plate (7) The slope at station No.(7). (a) Side view showing the slope detached blocks and residual sediment (soil slope), photo direction is SW. (b) Front view showing overhanging slope, discontinuities and residual sediment, photo direction is SW.

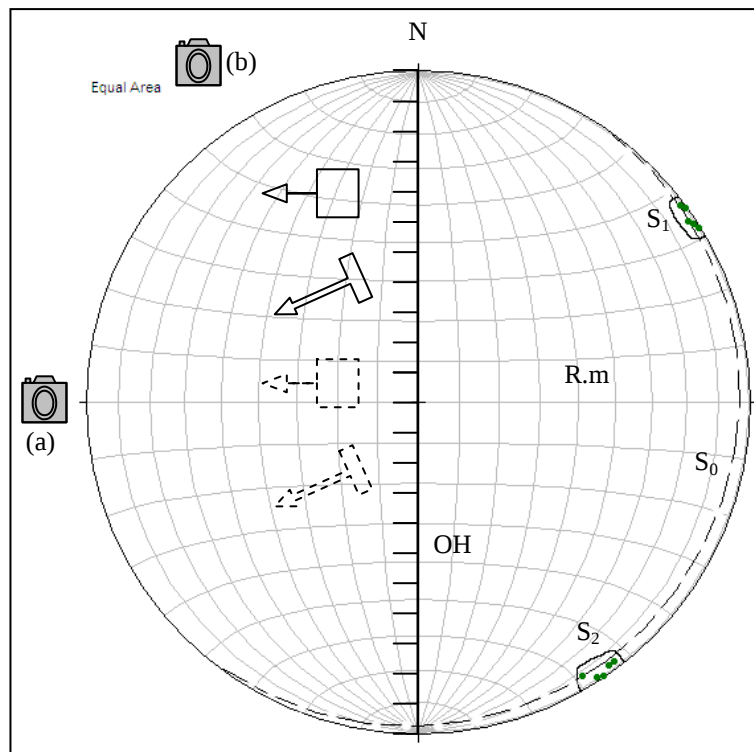
This station lies at latitude (32° 31' 14.3" N) and longitude (043° 47' 44.1" E), within Injana Formation, (fig. 1-a, plate 1). The slope is (20m) high, (50m) long along its trend, and its inclination is (270/90°-OH). The average dip of strata is (126/4°), therefore it is subhorizontal-layer slope, (fig. 2).

Figure (2) Stereogram of discontinuities, slope and types of failure for station No.(1). In Tar Al-Sayyed area, Karbala Governorate, Iraq.

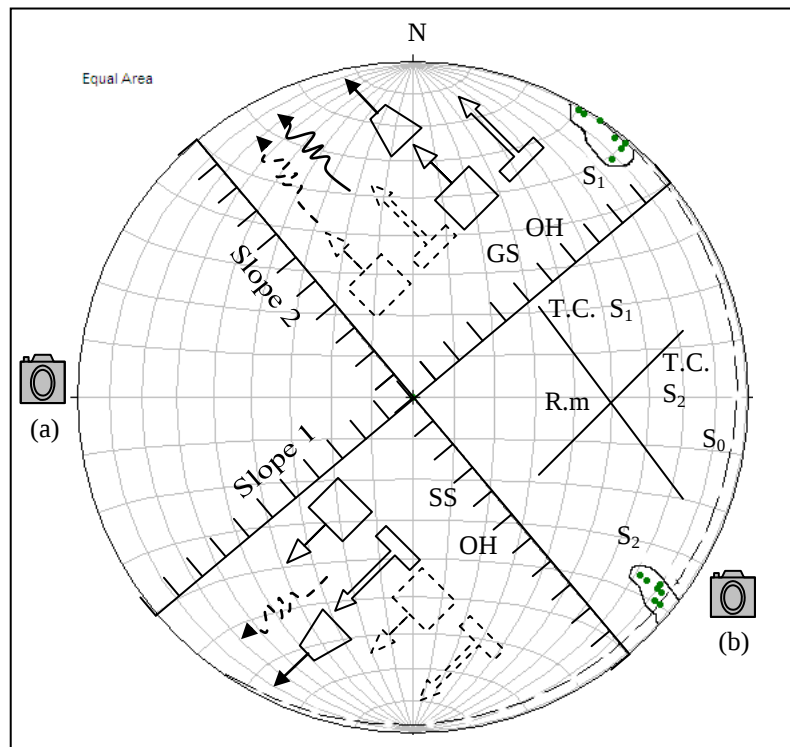
Figure (3) Stereogram of discontinuities, slopes and types of failure including tension crack toppling for station No.(2). In Tar Al-Sayyed area, Karbala Governorate, Iraq.

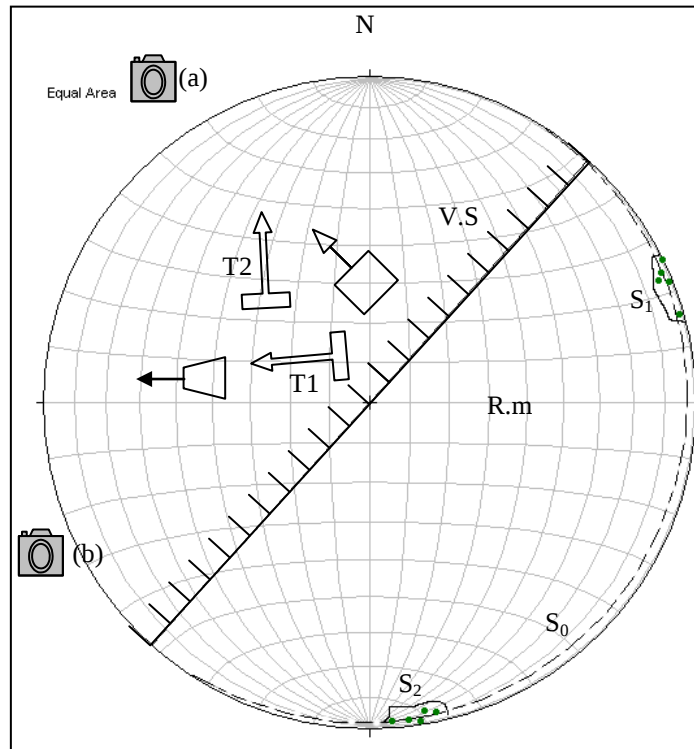
Figure (4) Stereogram of discontinuities, slope and types of failure including multidirectional toppling for station No.(3). In Tar Al-Sayyed area, Karbala Governorate, Iraq.

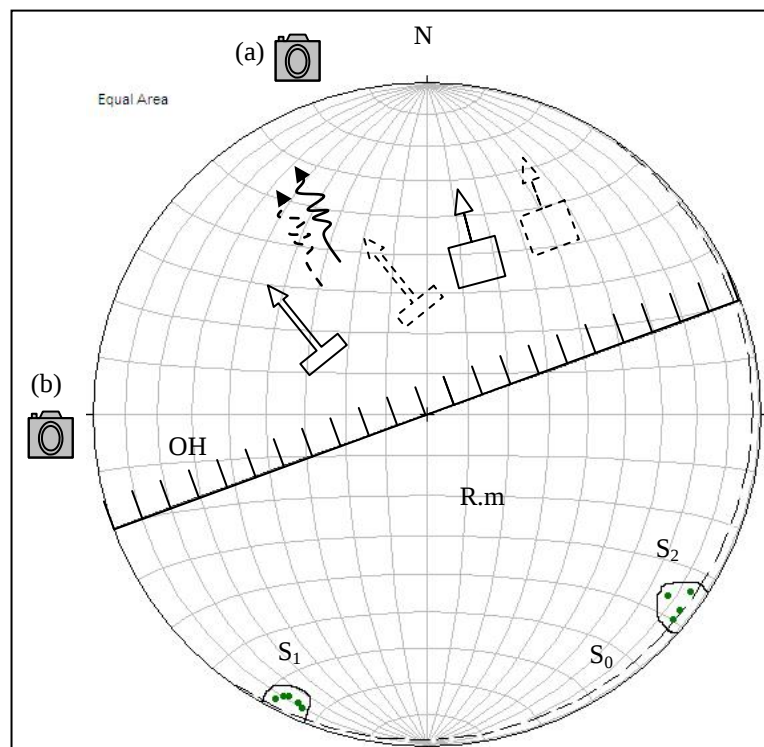
Figure (5) Stereogram of discontinuities, slope and types of failure for station No. 4. In Tar Al-Sayyed area, Karbala Governorate, Iraq.

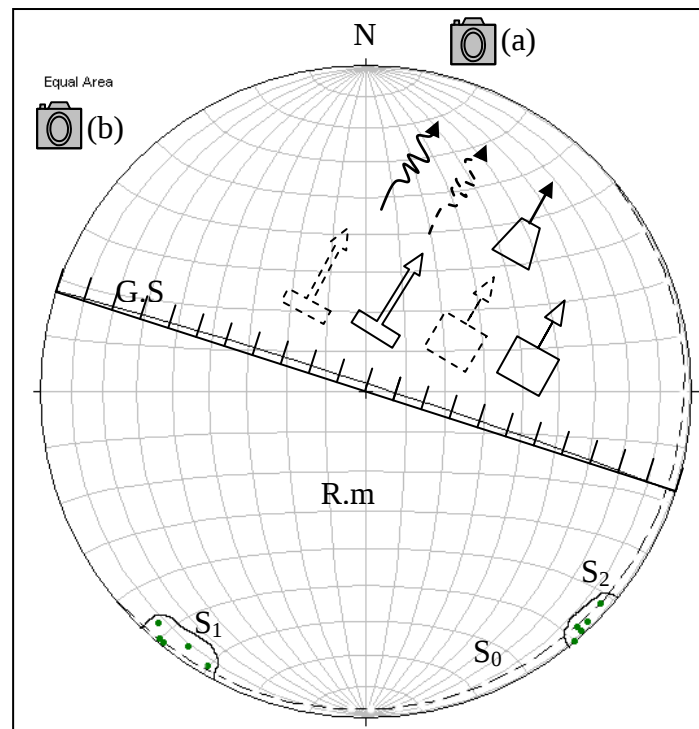
Figure (6) Stereogram of discontinuities, slope and types of failure for station No.(5). In Tar Al-Sayyed area, Karbala Governorate, Iraq.

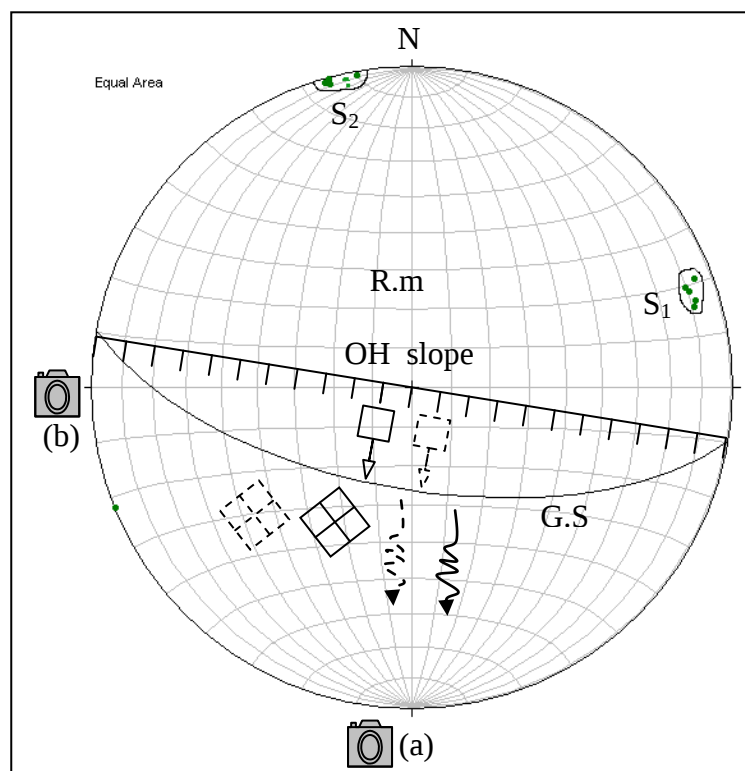
This station lies (6m) to the north side of AL-Hij Al-Barry road, at latitude ( $32^\circ 28' 37.3''$  N) and longitude ( $043^\circ 46' 51.7''$  E), within Dibdibba Formation, (fig. 1-b, plate 6). The slope is (2.5m) high, (65m) long along its trend, its inclination is ( $190/64^\circ$ -OH). The bedding planes for this station are not visible. The rocks are massive, (fig. 7).

The sandstone layer is cut by two sets of subvertical joints in (S1&S2), (fig. 7). The spacing of joints in (S1) ranges between (1.7-2.3m), their persistence reaches (1m) on the slope and they are almost tight. The spacing of joints in (S2) ranges between (0.8-1m), their persistence reaches (1m) on the slope and they are almost tight, (plate 3-b).

Figure (7) Stereogram of discontinuities, slope and types of failure for station No.( 6). In Tar Al-Sayyed area, Karbala Governorate, Iraq.

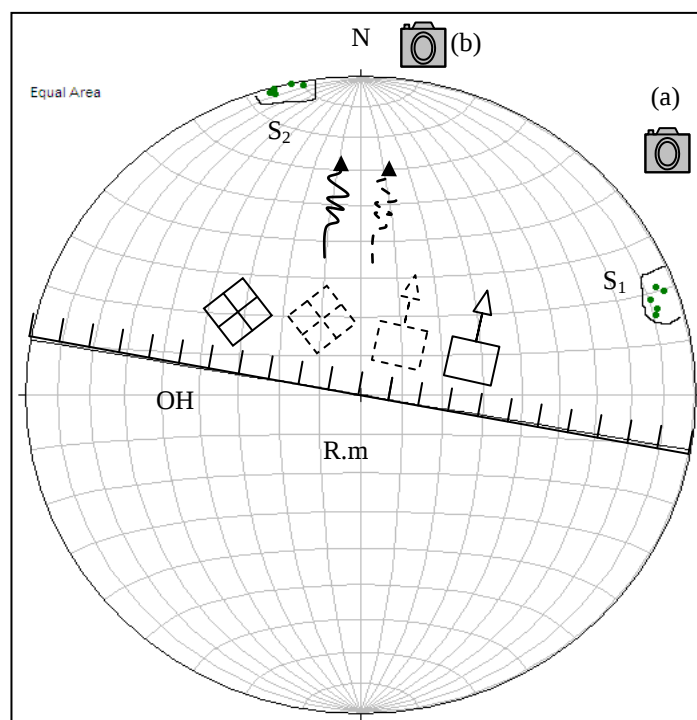
Figure (8) Stereogram of discontinuities, slope and types of failure for station No.( 7). In Tar Al-Sayyed area, Karbala Governorate, Iraq.
