# Slope Stability Evaluation of Euphrates Out Crops at Najaf Governorate-Center of Iraq: Analysis Study

In this study the stability of the rock has been evaluated to determine the most relevant factors affecting instability of slope. The discontinuity data collected from the field surveys was analyzed using stereograph projection. Sub horizontal-layer slopes of limestone rocks in Euphrates formation at Al-Najaf governorate, center of Iraq, presence of failures in slopes, Its from most to least rock fall, secondary toppling, and rolling. The degree and nature of hazard risk depend on properties of the rock discontinuity. This study recommends that rock instability is enhanced by fences barrier and building concrete walls and remove weak rocks.

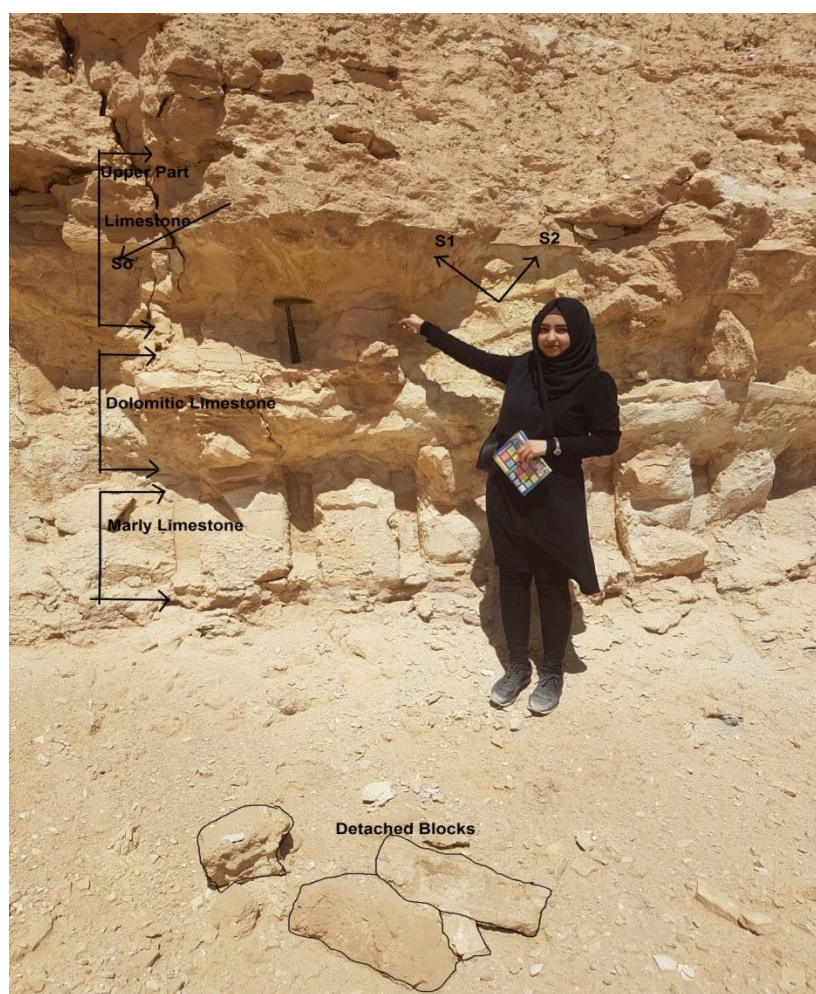
**S.2:** The Euphrates outcrops are located at latitude ( $31^{\circ} 50' 3.248''$  N) and longitude ( $44^{\circ} 14' 14.771''$  E) (picture 2). The slope is 6 meters high, 15 meters long, and 320 degrees inclined. Because the average dip layer is  $170/04^{\circ}$ , it has a subhorizontal – layer slope. A 3 m thick stratum is exposed at the top of the hill. They are LIMESTONE ( $c = 38$  MPa), pale green, thick bedded, and moderately strong

were failureg through the limestone layers .The spacing of discontinuities in S1 ranges from 0.7 to 1.3 m, their persistence on the bedding plane reaches 2.5 m, and they are nearly open up to 0.13 m. S2 has a discontinuity spacing of 1–2 m, 2.5 m persistence on the bedding plane, and can expand up to 0.13 m. failure Rock block has occurred through rock fall or toppling.

picture 2: slope and discontinuities of S(2), photo direction NE

1. Lifting unstable rock masses that are affected to toppling and rock fall in critical cases.
2. Filling the lower parts of the slope toe with binders such as cement, rock bolts and chemical sodium silicates.
3. Continuous monitoring of cracks and joints in those areas, especially during the rainy season, to see the extent of these cracks and the emergence of new cracks.

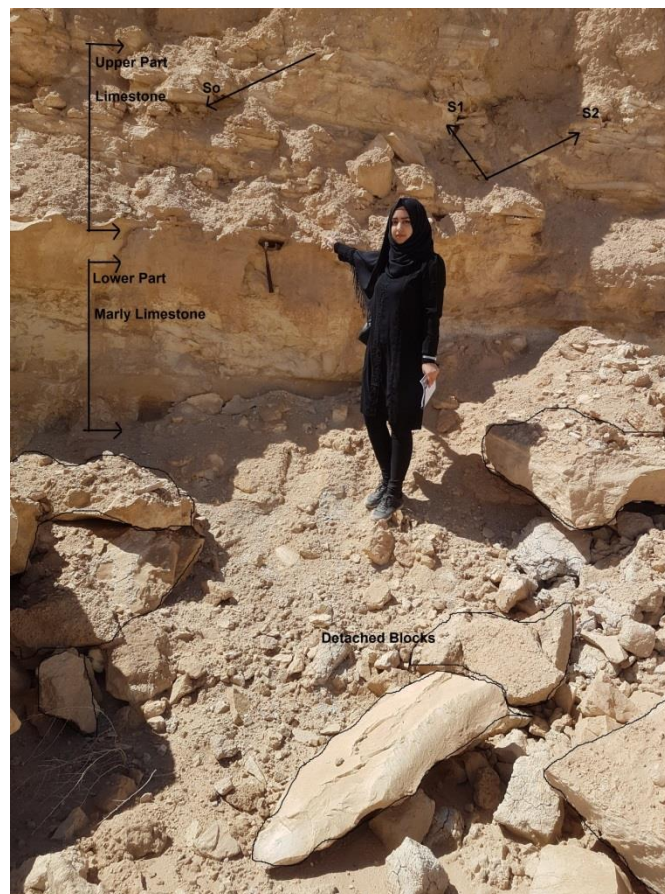
**S.4:** The Euphrates outcrops are located at latitude ( $31^{\circ} 51' 4''$  N) and longitude ( $44^{\circ} 15' 15''$  E) (picture 4). The slope is 5 meters high, 20 meters long, and sloped at  $260/84$  degrees. The average dip layer slope is  $250/02$ , making it a subhorizontal – layer slope. A 2 m thick stratum is exposed at the top of the slope. They are LIMESTONE medium strong ( $c = 32$  MPa), pale green, deeply bedded, and severely worn. The underlying rock strata in the lowest of the slope are 3 meters thick. MARLY LIMESTONE is light grayish, deeply bedded.

S1 and S2 were two sets of discontinuities that were cutting limestone layers. S1 has a discontinuity spacing of 1–2.2 m, 0.7 m persistence on the bedding plane, and opens out to 0.1 m. S2 has discontinuity spacing ranging from 0.4 to 1.2 m, 1.0 m persistence on the bedding plane, and opens up to 0.02 m. Rock fall failure due to differential erosion at the slope toe, overhanging slope in some areas, and contributing to the inclined soil slope can enable rolling of rock block detached.

**picture 4: The discontinuities and the slope of (S4), direction photo SW**
