### Slope Stability Assessment along Qalachwalan-Suraqalat Main Road, Sulaimani, NE-Iraq

Ghafor A. Hamasur, Nzh M. Qadir

Department of Geology, College of Science, University of Sulaimani, Sulaimani, Iraq

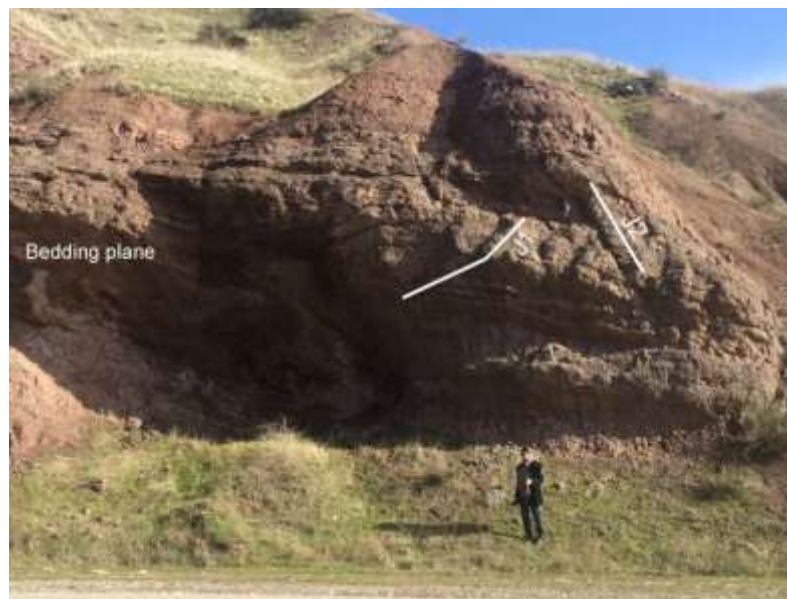
Fig. 6: General view for slope at station no.1 with marked discontinuity sets

4) Potential for direct toppling at stations 1, 2, 4, 5 & 7 about intersection planes [(So&J1, J1&J2), (So&J1), (So&J2) and (So&J1)] respectively, as shown in Figures 5d, 6, 7d, 8, 11d, 12, 13d, 14, 17d & 18.

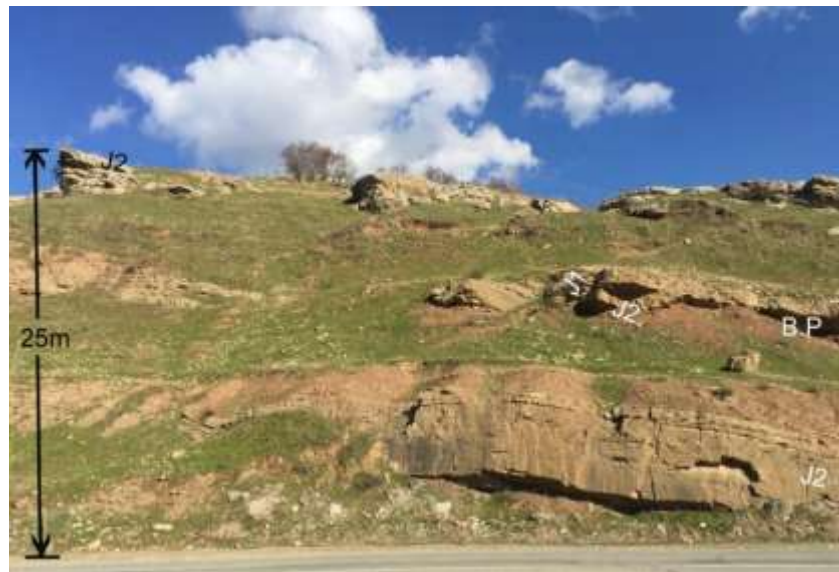
Fig. 8: General view for slope at station no.2 with marked discontinuity sets

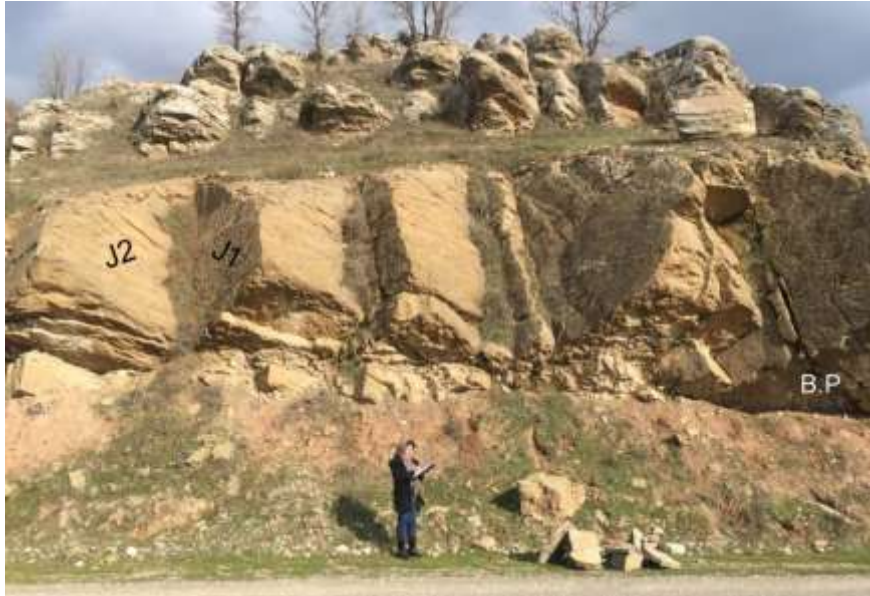
Fig. 10: General view for slope at station no.3 with marked discontinuity sets

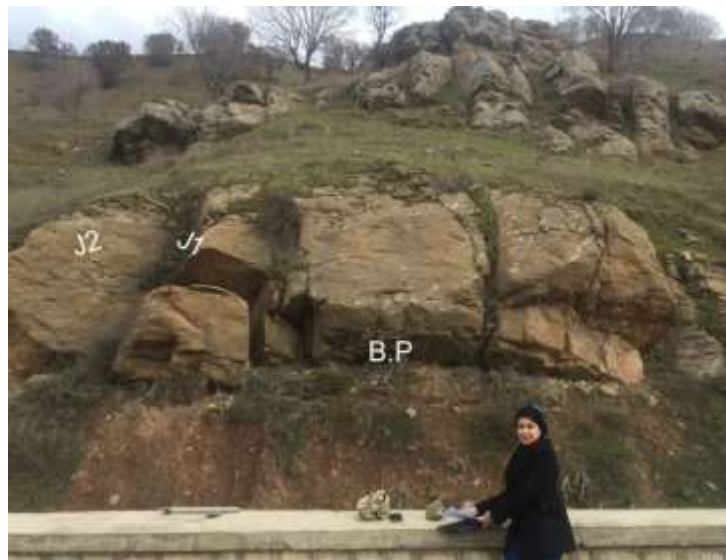
Fig. 12: General view for slope at station no.4 with marked discontinuity sets

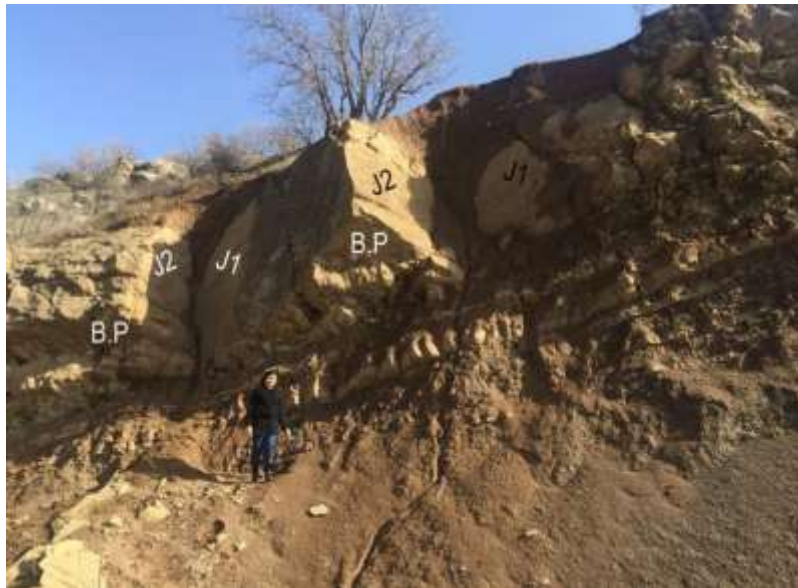
Fig. 16: General view for slope at station no.6 with marked discontinuity sets

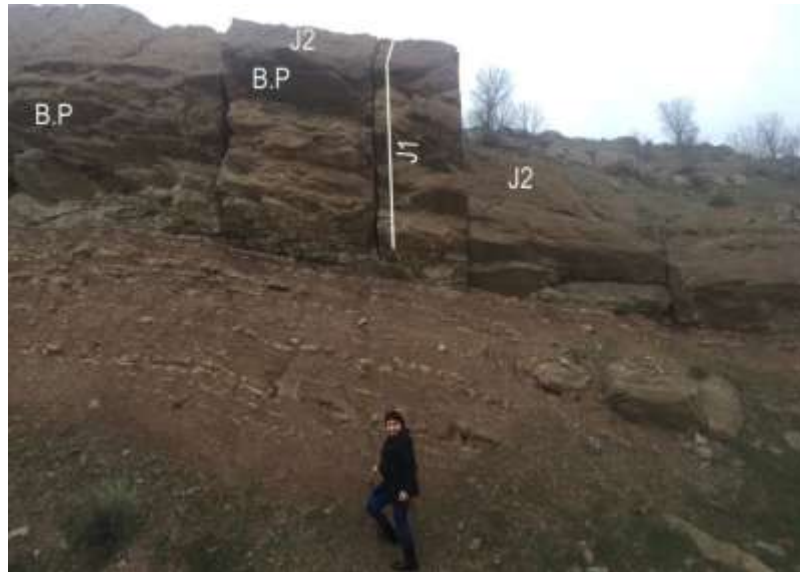
Fig. 18: General view for slope at station no.7 with marked discontinuity sets

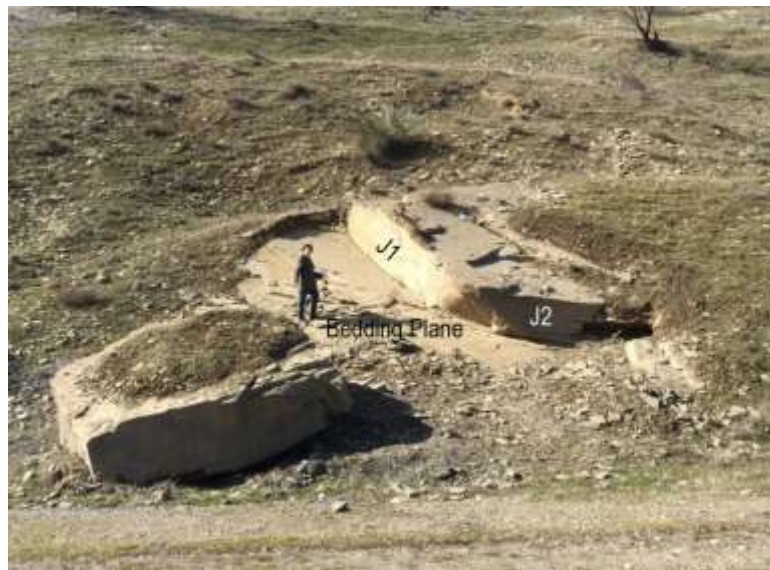
Fig. 22: General view for slope at station no.9 with marked discontinuity sets
